Survival Factors

Airbag Safety Study

October 8, 2009

Location: Boyd, TX
Aircraft Type: Cessna 172 SP
Accident Date: July 14, 2009
Accident Time: 1750 CDT
Accident Number: N2446F, CEN09LA442
Airbag Equipped: Yes

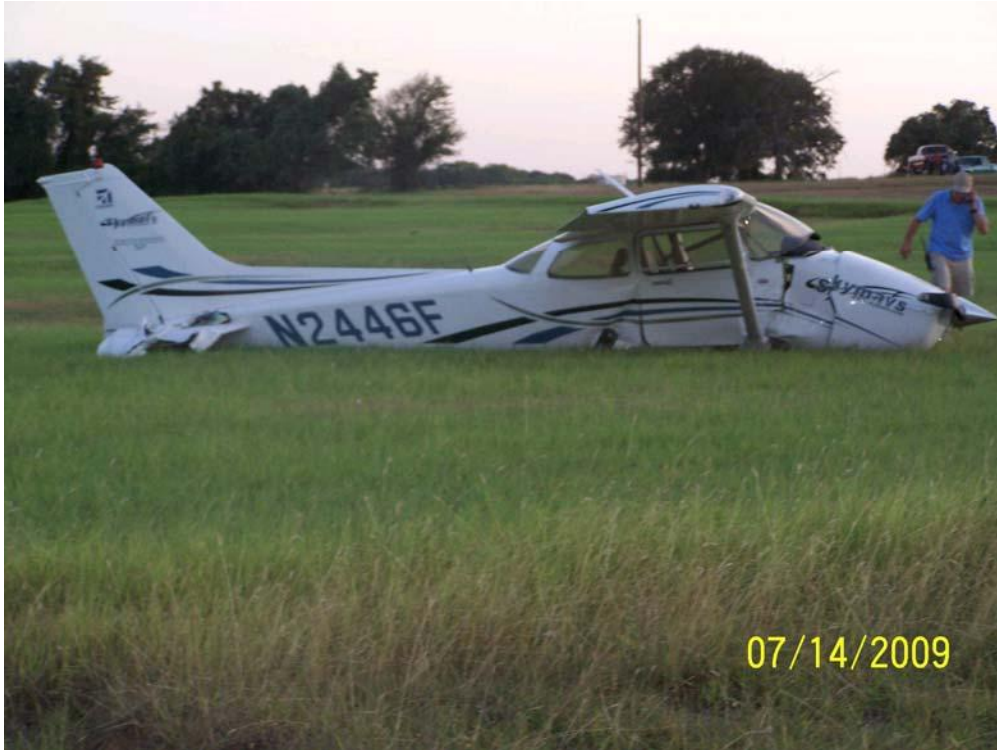
The airplane remained largely intact (figures 1 and 2). The firewall was buckled. The engine mounts were intact and the mounting tubes were not bent or cracked, with the exception of the right lower mount tube that was bent slightly to the right. The forward fuselage firewall and engine was displaced downward approximately 30 degrees -- from the instrument panel forward -- and approximately 5 degrees to the right.

Figure 1: On-scene photograph showing the damage to the aircraft.

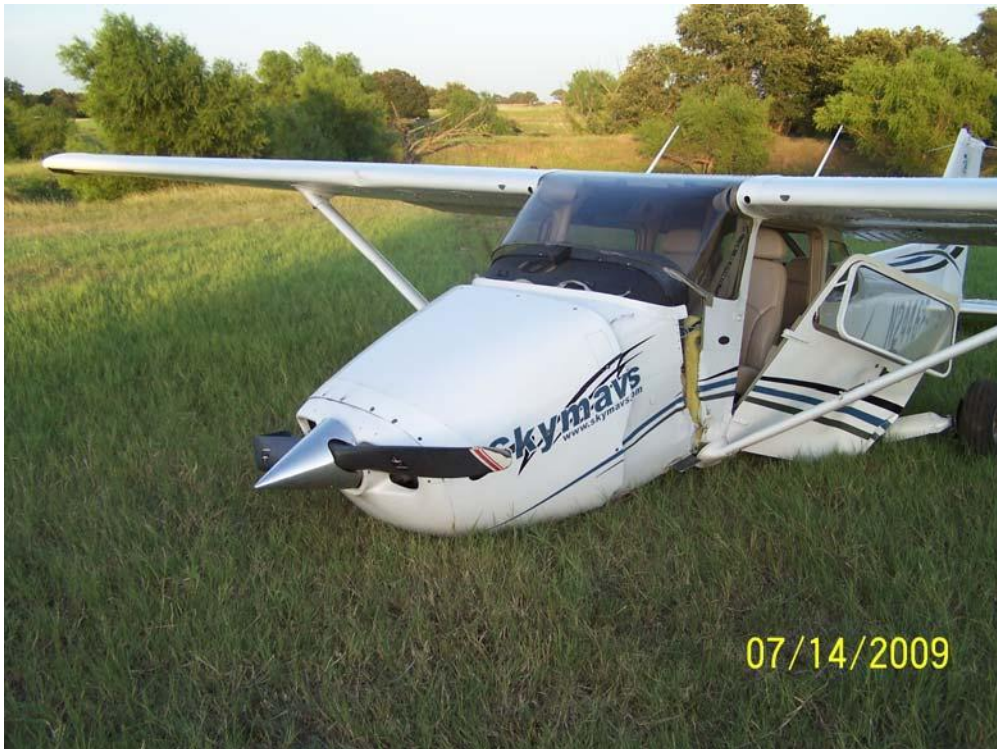
Figure 2: On-scene photograph showing the damage to pilot's side.

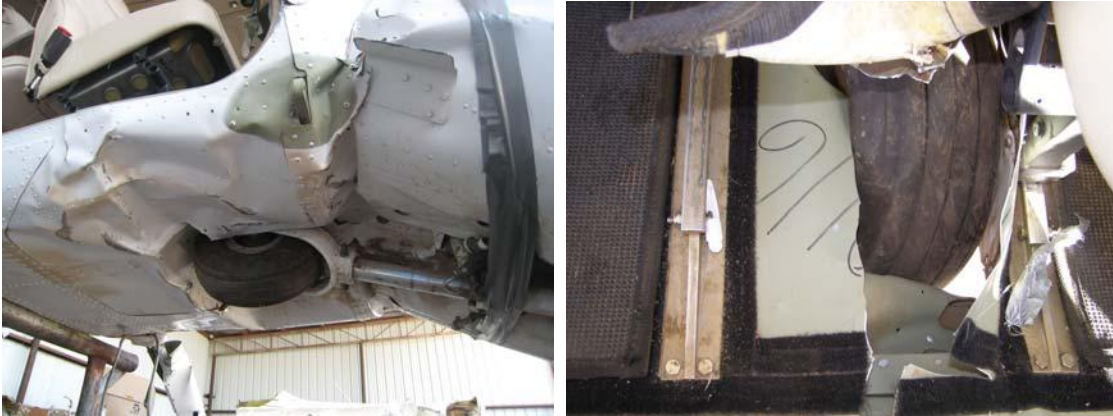
The nose gear was displaced aft, and was embedded into the fuselage (figures 3 and 4). It had ruptured the floor between the two forward seats and intruded into the cockpit about 3 inches.

Figure 3 and 4: Photographs of nose wheel intrusion taken during airbag exam.

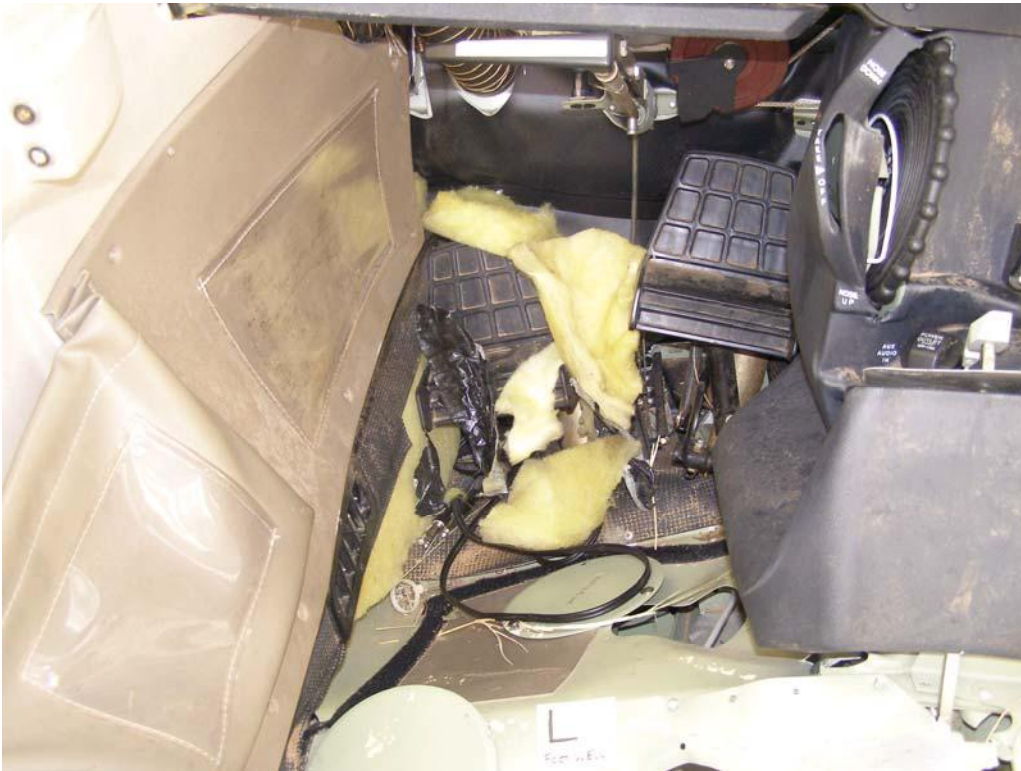
The instrument panel was intact, with the exception of some cracking of the paneling between the throttle and primer levers. The trim wheel and fuel selector valves were damaged and deformed inward, toward the left side foot well area. The rudder pedals and flooring below the pedals were bent and displaced (figure 5).

Figure 5: Photograph of left side (pilots) foot well taken during airbag exam.

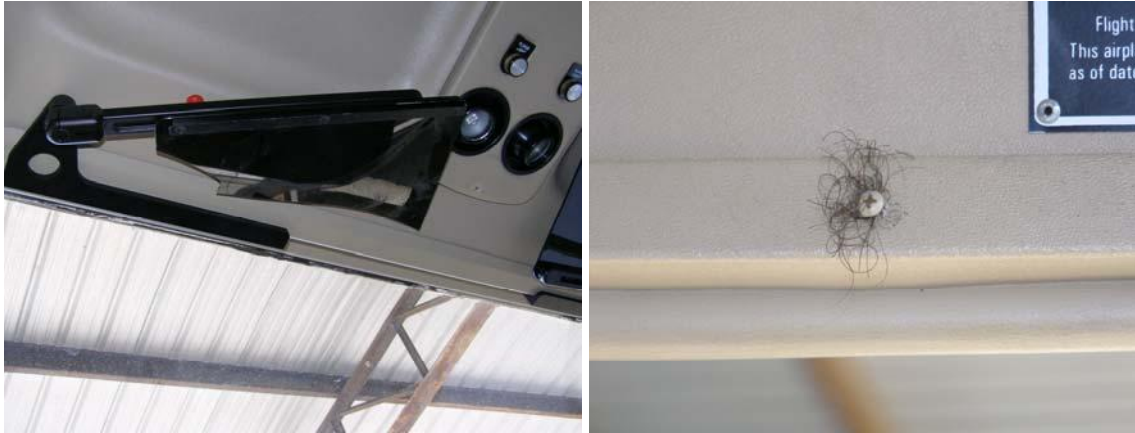
wing removal). The left visor was fractured, and hair remnants were found on the door molding screw, 2nd back from front (figures 6 and 7).

Figures 6 and 7: Photograph of broken visor and hair remnants in doorframe molding screw, respectively.

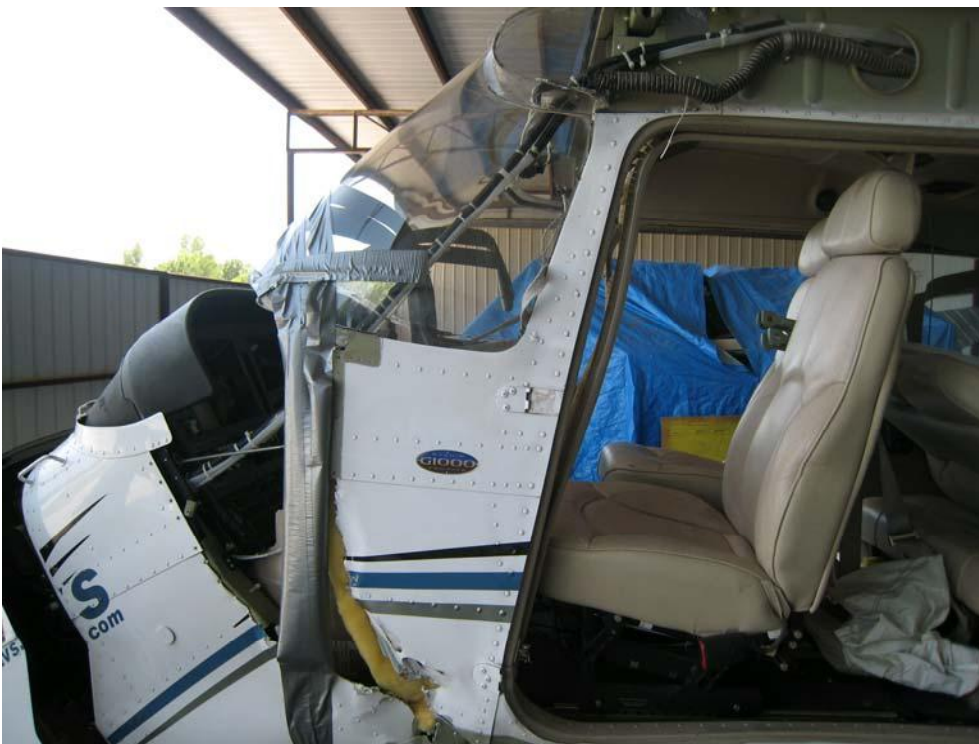
The front seats were measured and their dimensions are documented on an exemplar photo in figure 8. The left seat (figure 9) was occupied by the pilot. The seat was intact. The seat position locking pins were fully engaged in second hole from front. Damage was observed to right front wheel assembly from impact with seat rail. The seat pan was displaced approximately 0.25" at the front bend line and 1.40" at the aft bend line (compared to the undamaged right seat measurements)

Both sets of seat rails were intact and attached to the floorboard. The right seat's seat rail appeared unremarkable. The left seat's left inboard rail was bent upward at the forward end approximately 1" from the nose wheel penetration. The left seat's outboard rail appeared unremarkable.

Figure 9: Photograph taken during wreckage exam of condition and position of left seat.

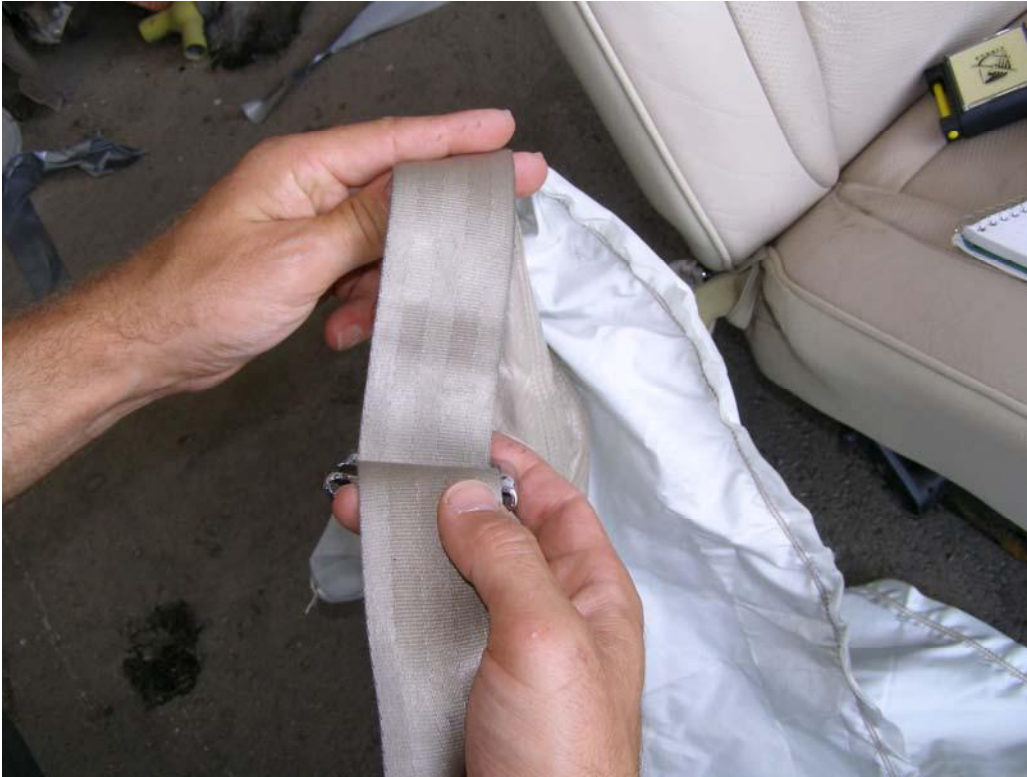
The accident airplane had three-point restraints. The front left seat restraint buckle loadbar was found 29” from the anchor inside the cabin. A witness mark was observed at that location (figure 10). The connector tongue showed no marks outside normal wear. The seatbelt retractor functioned properly.

Figure 10: Photograph of witness mark on front left restraint.

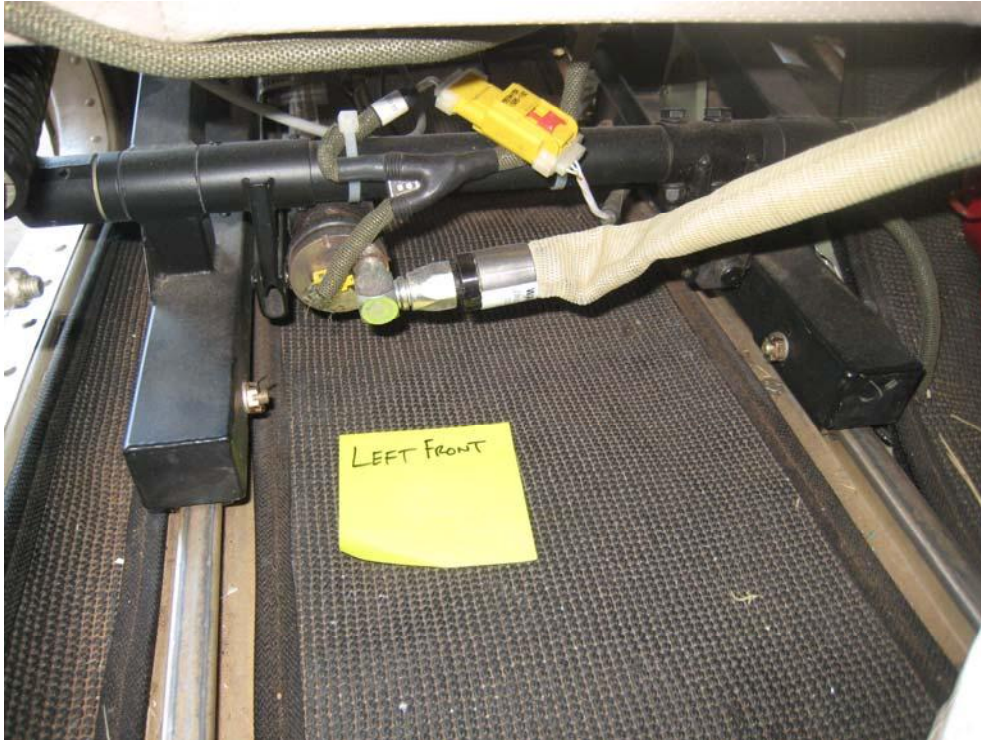
The front left seat airbag system was found deployed, intact and still connected. The system was photographed and then AmSafe staff disconnected the inflator (figure 11). The inflator part number was 508794-401. No bag seam tears were noted on the left airbag (figure 12). There was some tearing of the airbag cover and some stitching that had pulled out at mouth of bag (figure 13), which is normal for loaded bag. The airbag width was 17" and height was 30".

Figure 11: Photograph showing left side airbag system remained connected to inflator

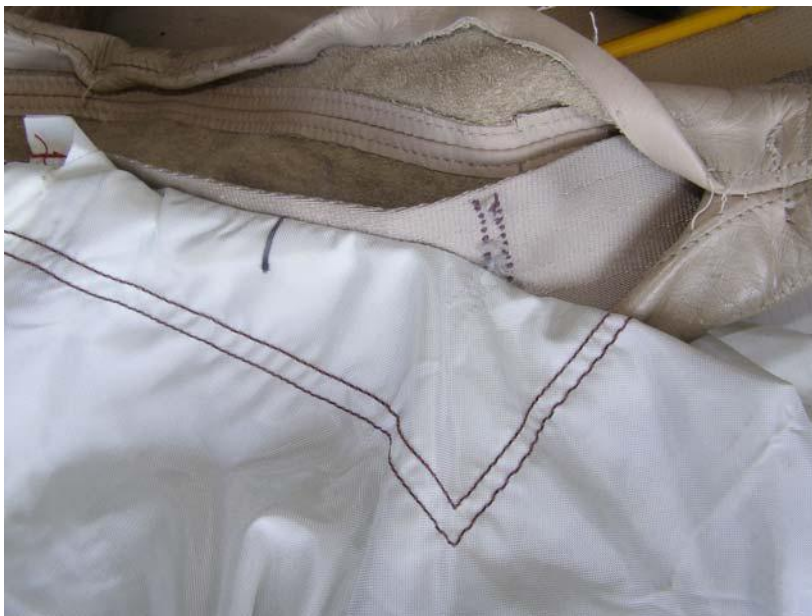
Figure 12: Photograph of tearing of airbag cover, and stitching pulled out at mouth of bag

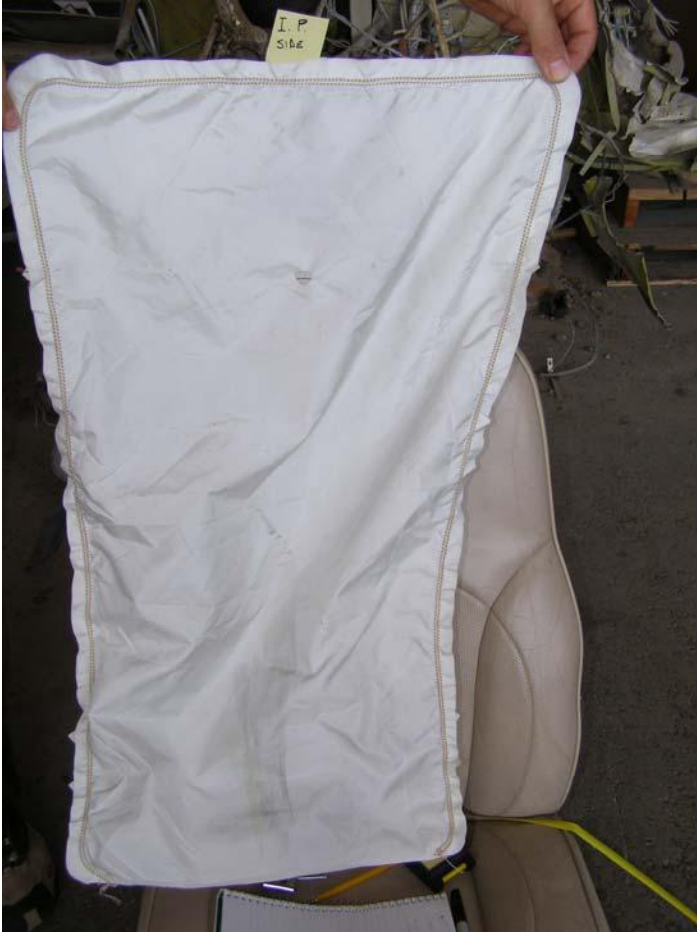
Figure 13: Photograph of instrument panel side of left (pilot's) airbag.

The vent hole on the instrument panel side of the airbag (figure 14) was slightly squared at two locations, about 3 threads. There was a greenish vertical mark starting at the bottom of the bag, extending upward 7.5". The greenish mark was located 7.5" from outboard edge and 6.75" from inboard edge of the airbag. A black mark 1.125" wide was noted, at 6" from outboard edge and 7" from inboard edge. There was a black/grey scuff mark near center of bag. Another black/grey scuff mark was observed near the vent hole, 3" long, 7.5" from outboard edge and 8.75" from inboard edge of the airbag.

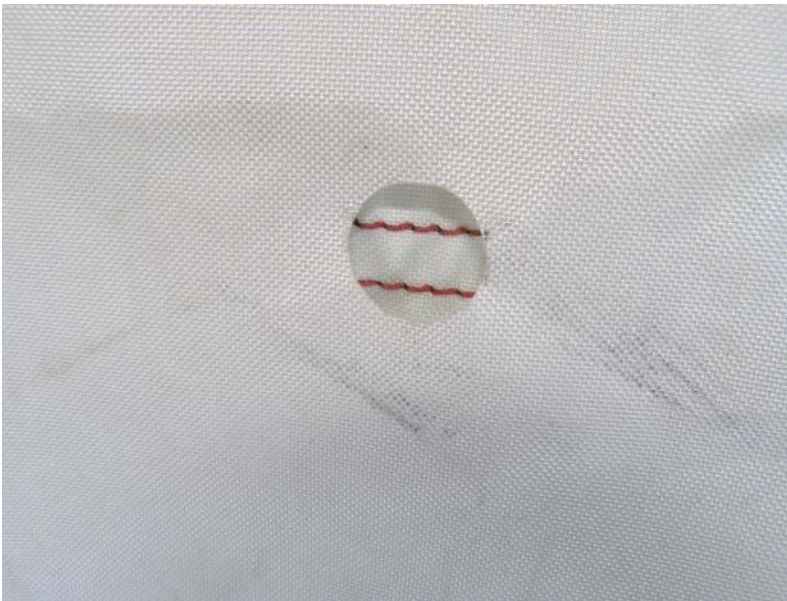
Figure 14: Photograph of vent hole on instrument panel side of left (pilot's) airbag.

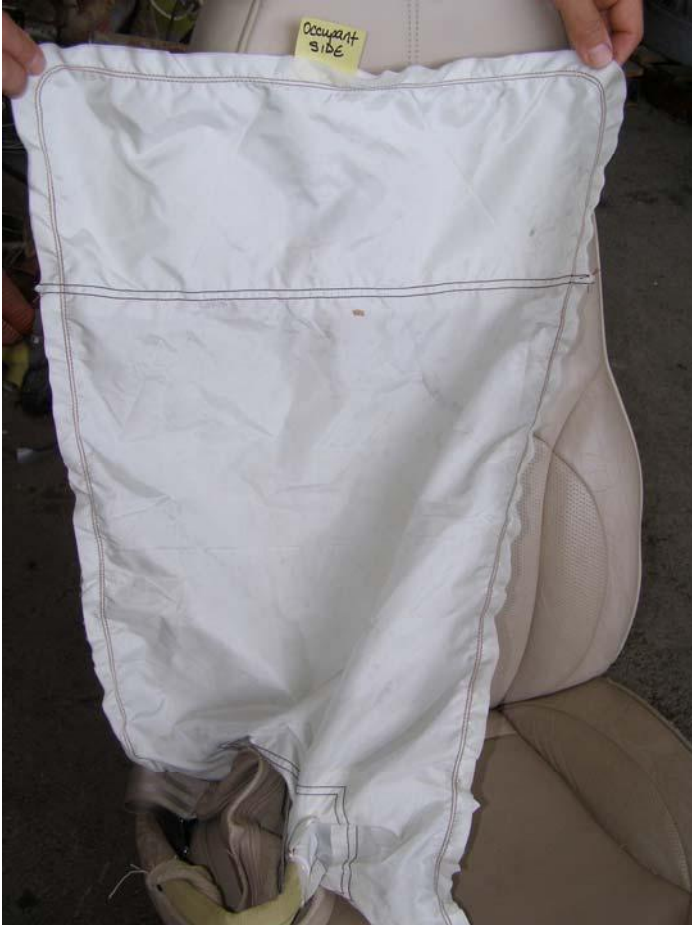
Figure 15: Photograph of occupant side of left (pilot's) airbag

There was a blood spot found on the occupant side of the left airbag (figures 15 and 16). The blood spot was 7.5" from the top of the bag, 8" from inboard edge of bag and 9.5" from outboard edge. A black mark 4.5' long was observed, beginning 4' from inboard edge and ending 6.5' from inboard edge. A crescent shaped black mark at center of bag 2.25" long, starting 8.5" from inboard edge and ending 6.5" from inboard edge.

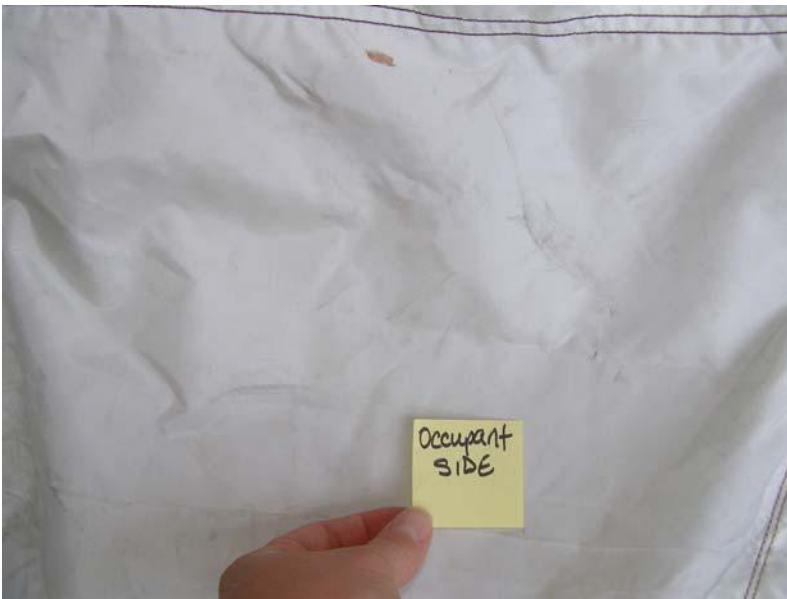
Figure 16: Photograph of blood and scuffing on occupant side of left (pilot's) airbag
